RE: L7579 Field Advisory Dated February 3, 2017

## **L7579 REPAIR & REPLACEMENT POLICY**

**FIELD ADVISORY**

**L7579 1-3/4" X 1-1/4" MNPT Filler Valve  
Date Codes 8B16 to 1C17**

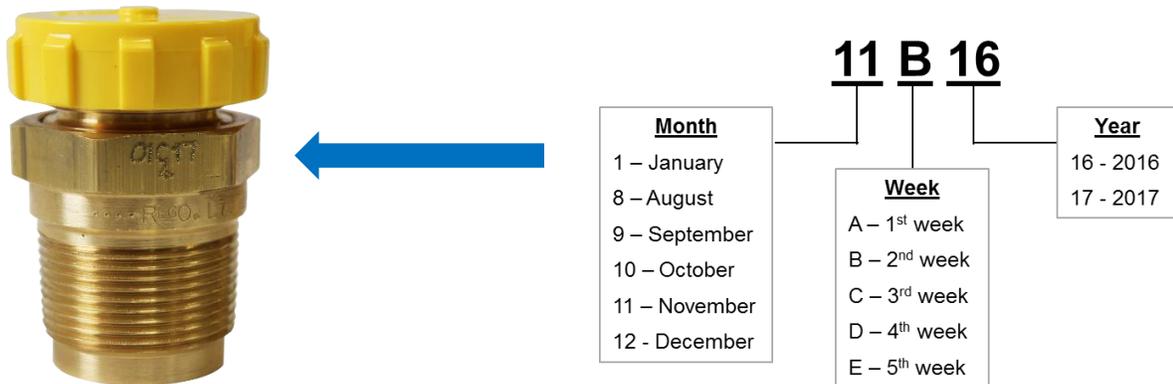
### Date Code Identification

The dates of manufacture of the valves covered by this field advisory are August second week 2016 (8B16) to January third week 2017 (1C17).

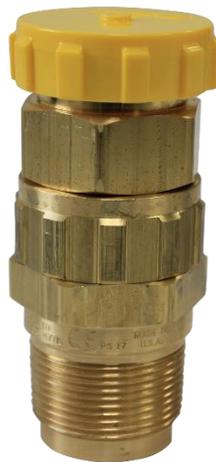
**L7579 with a 3179B installed.**

It is a good practice to use filler hose adapters like the 3179B when conducting any filling operation into a 1-3/4" ACME filler valve. When a filler hose adapter is attached to the hose end valve connection during the filling process and there is a problem disconnecting due to leakage through the upper check, the 3179B or other type filler hose adapters can remain on the subject filler valve. This will allow the delivery person to safely disconnect the hose end valve from the filler hose adapter which will remain connected to the subject filler valve leak free.
